Reconstruction of the Grenfell Tower Fire—Thermomechanical Analysis of Window Failure During the Grenfell Tower Disaster

Maxime Koohkan, Virginie Dréan, Bertrand Girardin, Eric Guillaume and Xavier Duponchel, Efectis France, route de l'Orme Des Merisiers, 91193 Saint Aubin Cedex, France*

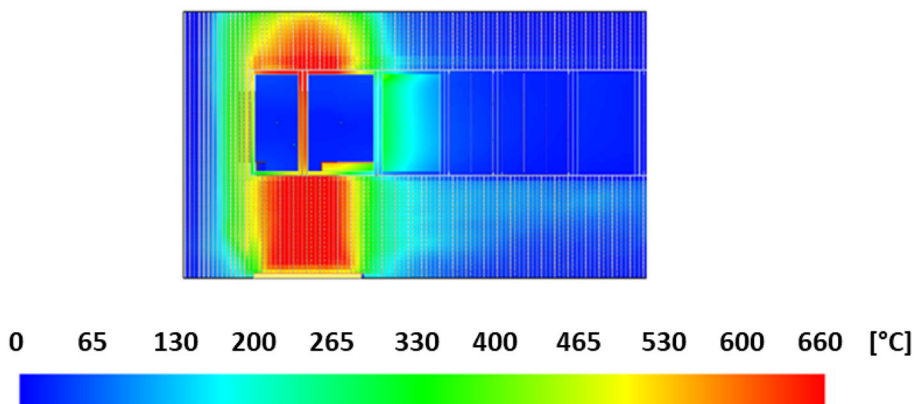
Figure 5. Numerically modelled temperature of the external window on the 5th floor, directly above Flat 16 of the Grenfell Tower, after 4 min of façade fire exposure [34].

the external frame of the window located at the 5th floor, directly above Flat 16, were subjected after 4 min of façade fire exposure. The heat flux fields applied to the exposed face of the window are addressed in Fig. 6a. The position for each part of the window is indicated in Fig. 6b. These thermal loads are representative not only of fire break-out through a typical window, but also of the developed façade fire during vertical fire spread over the tower, as observed in Fig. 7. At later stages of the façade fire, the numerically estimated thermal loads (in terms of gauge heat flux) on window frames are consistent with the general flux evolution indicated in Fig. 6. The maximum heat fluxes imparted to Parts 1, 5 and 7 of the window frame (Fig. 6b) is about 120 kW/m^2 after 3–4 min of fire exposure, while the minimum heat fluxes evaluated for the lower Parts 2 and 6 and lateral Part 3 of the window frame (Fig. 6b) are between 30 and 70 kW/m^2 . There are differences for the windows attacked thermally during horizontal fire spread where thermal gradients can change slightly. Flames affect Part 8 of the frame before Part 5 (Fig. 6b) but the delay in such horizontal gradients is less than 1 min.

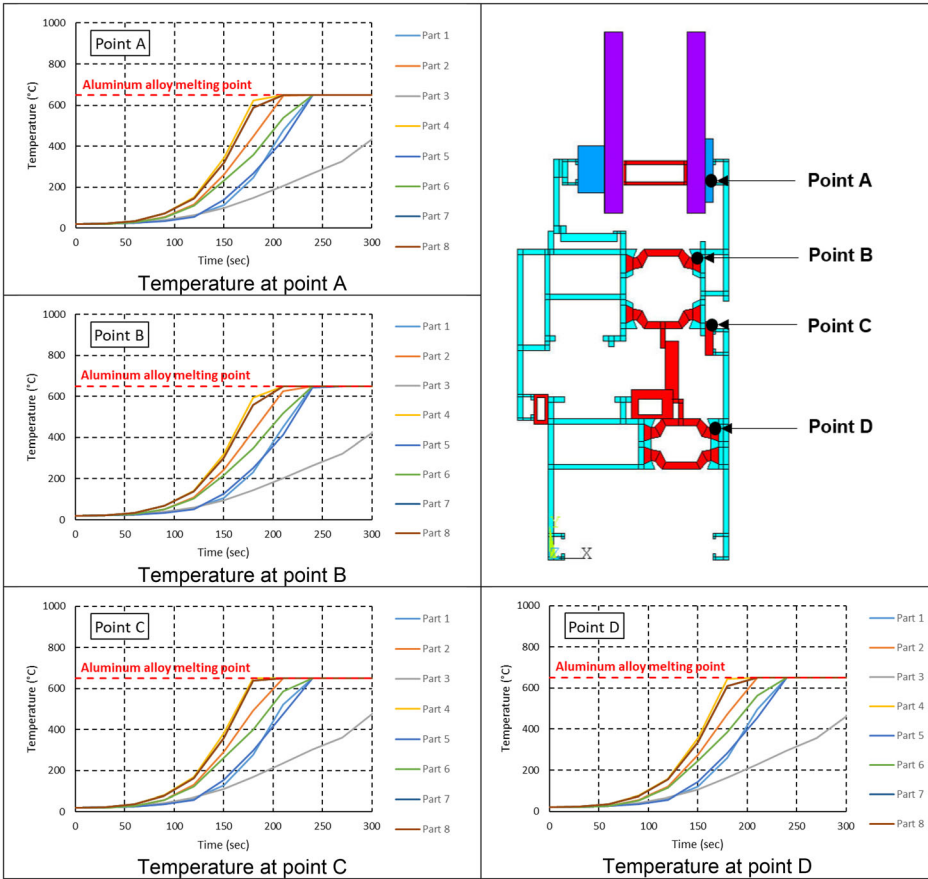
Figure 12. Temperature over time, evaluated at four locations (A, B, C and D) in the window frame.

Time-history temperatures are evaluated for all of the frame sides (Parts 1 to 8). Temperatures at four locations A, B, C and D, located close to the polyamide thermal breaks, are indicated in Fig. 12. Temperatures are up to 80°C between 1.5 min (on Parts 4 and 8) and 2.5 min (on Part 3) of external fire exposure of the polyamide thermal breaks, and up to 200°C between 2 min (on Parts 4 and 8) and 4.5 min (on Part 3) of exposure for all positions close to the external side. This is consistent with the numerical observations in [34] where the external fire breaks the left part of the window first. Therefore, the thermal failure of the window frame is expected before 5 min of external fire exposure. This is consistent with the criterion of 4 min for the partial window failure considered in the fire model [34].

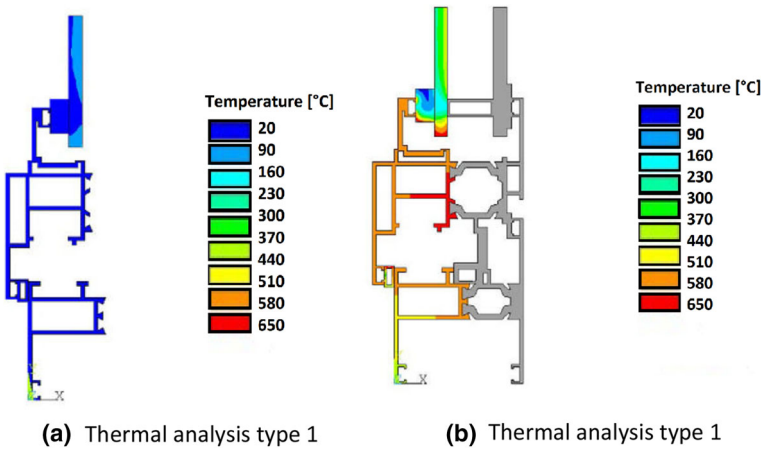
Figure 14. Temperature fields at 240 s of fire exposure for the inner section of Part 8—(a) with external section in place (b) without the external section.

The thermal heating of the internal profile of the window frame, in the above model, is no longer valid after the failure of the outside section of the frame.

Therefore, a new thermal analysis was set up (called thermal analysis type 2). The outside section of the window frame wall is deactivated. Surface boundary elements and conductive elements are removed (so called killed) during the analysis. Then, the new boundary surface elements are created (so called birth) on the inner face of the internal profile at 3 min. The thermal fields for Part 8 of the window frame at 240 s of fire exposure are shown in Fig. 14. Figure 14a shows the temperature field on internal profile of the window frame at 240 s, assuming that the external profile resists thermal heating (thermal analysis type 1). The maximum temperature is lower than 90 °C for the inner profile of Part 8 at this time. Figure 14b shows the temperature field of internal profile of the window frame at 240 s, assuming that the external profile fell away or melted at 3 min (thermal analysis type 2). The temperature of the internal profile, when the external profile has fallen away or melted, indicates that the internal profile may well melt or fall away before 4 min (240 s).
